**Hoh River Miles 17 to 40: Oxbow Canyon and Mount Tom Creek**

**July 2004**

# **Summary Report for Geomorphic Assessment of Hoh River in Washington State**

## **River Miles 17 to 40 between Oxbow Canyon and Mount Tom Creek**

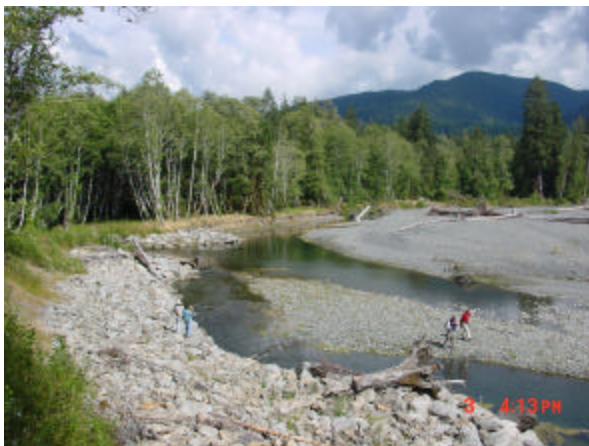
The valley and HCMZ widen in the Hoh Ranger Station Reach. The average active channel width increases from 380 to 490 feet. The HCMZ in the upstream portion of the reach is bounded by alluvial-fan deposits, and the HCMZ in the downstream portion is bounded by alluvial banks. The active channel width is nearly equivalent to the width of the HCMZ, and is composed of multiple low-flow channels. A large amount of wood is present in the active channel in this reach. In the lower portion of the reach, the Olympic National Park Ranger Station and Rainforest Campground have been constructed on the right bank, both within and outside of the HCMZ (figure 3). The largest modification to the HCMZ is evident in the 1977 aerial photographs, where a historical channel path was blocked off by a campground road, thus effectively constricting the HCMZ.

**Figure 3. Looking upstream at armored bank and engineered fish passage created at outlet of Taft Creek and a portion of the Rainforest Campground. The banks visible in this photograph are within the HCMZ. Armoring and fill operations have cut off historical channel paths and constricted the HCMZ in this area. Photograph taken by Reclamation in August 2002.**

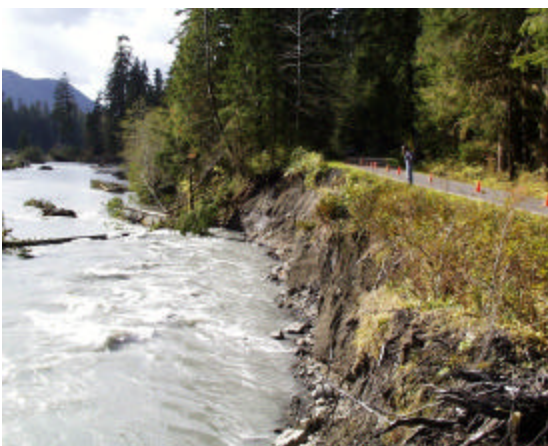
The Olympic National Park Road roughly follows the right HCMZ boundary. The Olympic National Park road may restrict the translation of meanders at the upstream end of the reach. However, the HCMZ boundary is so close to the valley side that meander movement would be restricted naturally in about this same location. Even though future erosion of the HCMZ boundary is expected to be minimal, small amounts of erosion could jeopardize the road in places where it is close to the boundary. The section of road along the ridge of glacial deposits is particularly vulnerable to erosion. The Park Road has already been setback to the valley edge in two places near MP 1.5 and 1.7 due to the road being too close to the edge of the HCMZ where river erosion was making travel on the road unsafe (figures 4 and 5).

**Figure 4. Looking downstream at section of Park Road near MP 1.7 in October 2000. Photograph courtesy of Olympic National Park.**

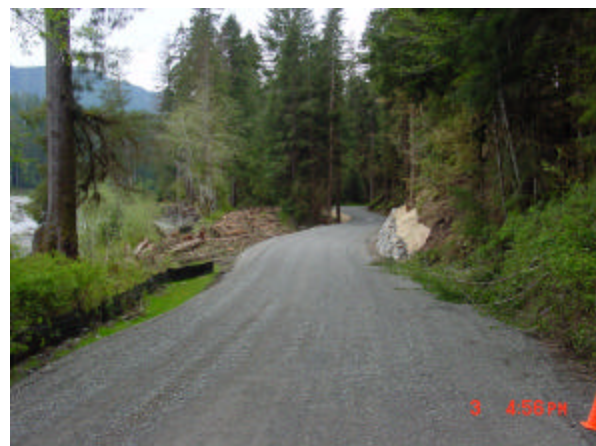
**Figure 5. Looking at same section of Park Road shown in Figure 4 in May 2001 following setback of road.**

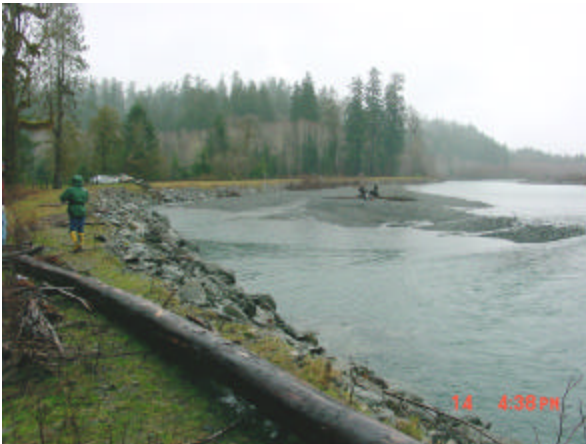
**Figure 7. Looking upstream at right bank of river where the County and Park Roads and a portion of Lewis Ranch have been armored within the HCMZ to protect them from further erosion. Photograph taken in March 2002.**

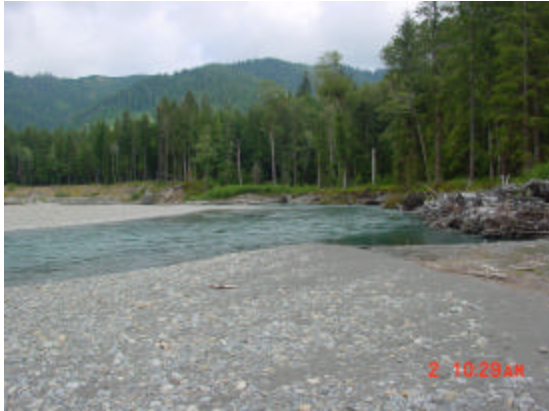
the County Road near MP 6.7 by rock armor that has been placed to protect the road (figure 9). Erosion is currently occurring at the upstream end of the bank at County Road MP 6.7 and along the road at MP 7.7. A high glacial bank on the left side of the HCMZ has glacial-lacustrine deposits that repeatedly slump into the Hoh River (figure 10).

**Figure 9. Looking downstream at County Road MP 6.7 where armoring has been placed to prevent further erosion. A log jam constructed by the County is visible on the right side of the photograph. Photograph taken in August 2002.**

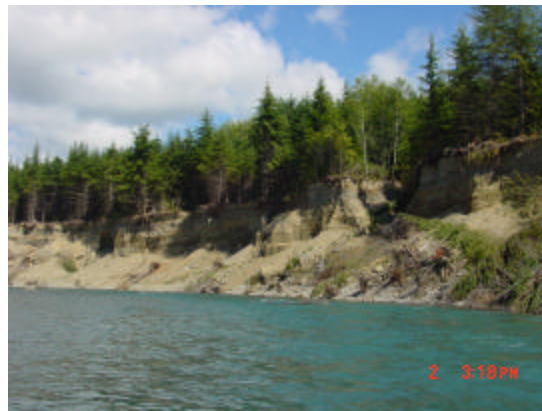
**Figure 10. Looking upstream and across at high glacial bank located in the downstream half of Reach 7 along the left side of the river. Photograph taken in August 2002.**

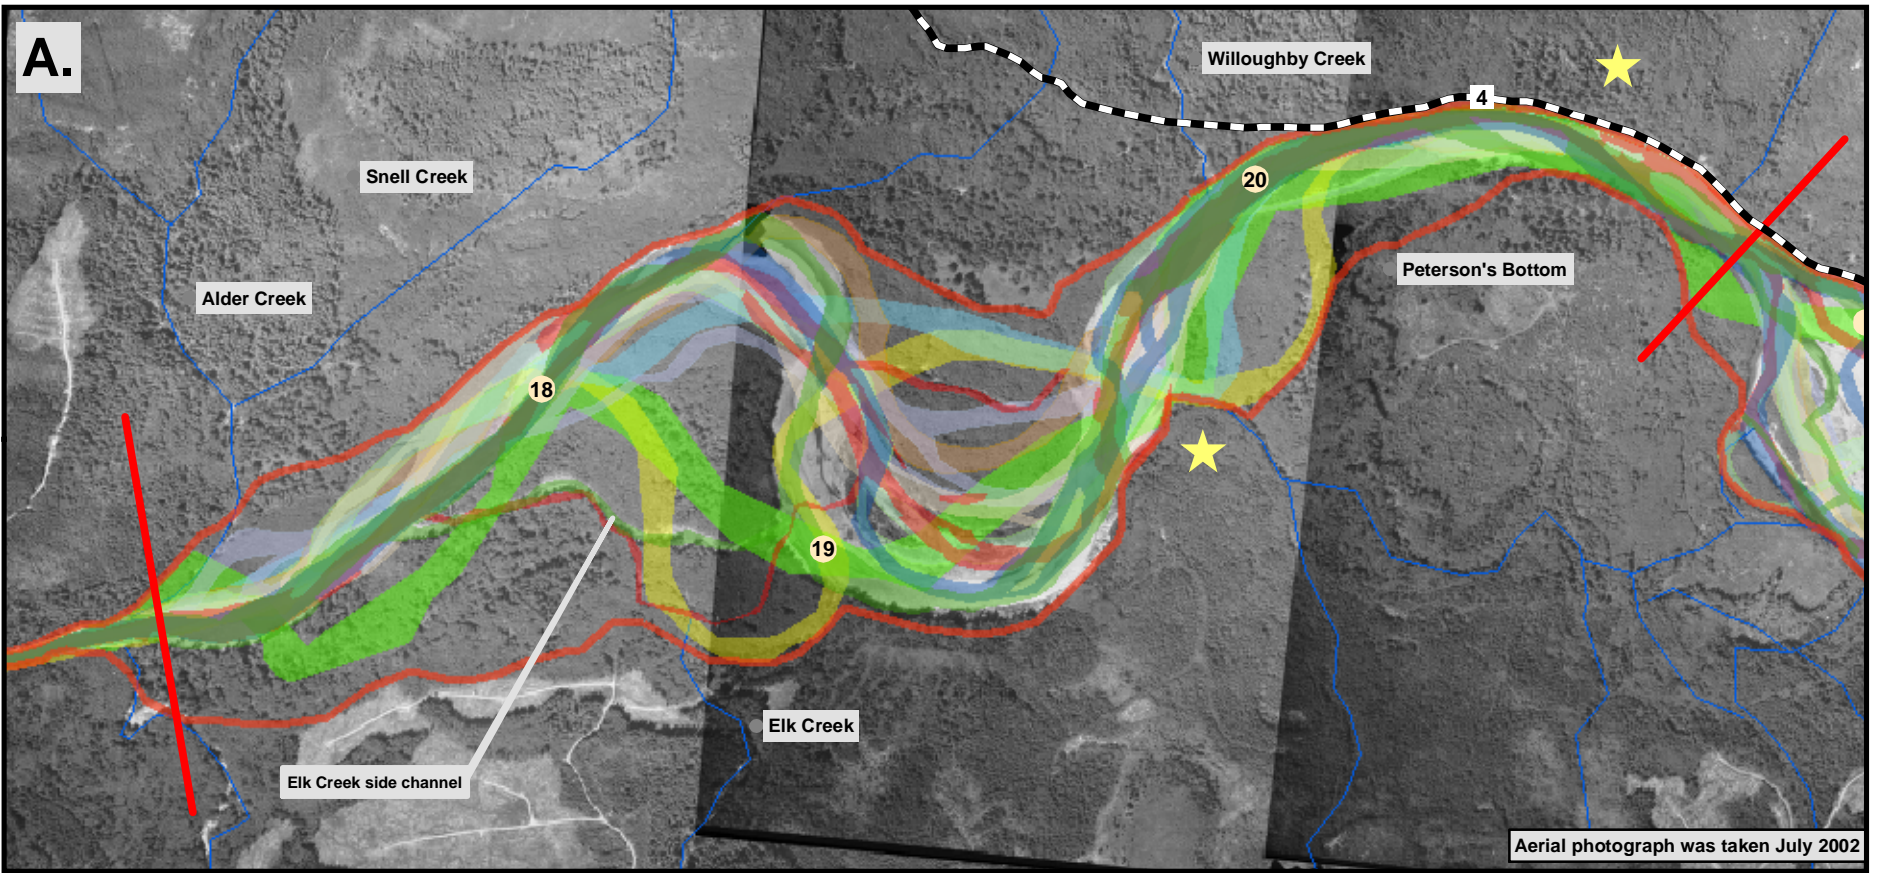
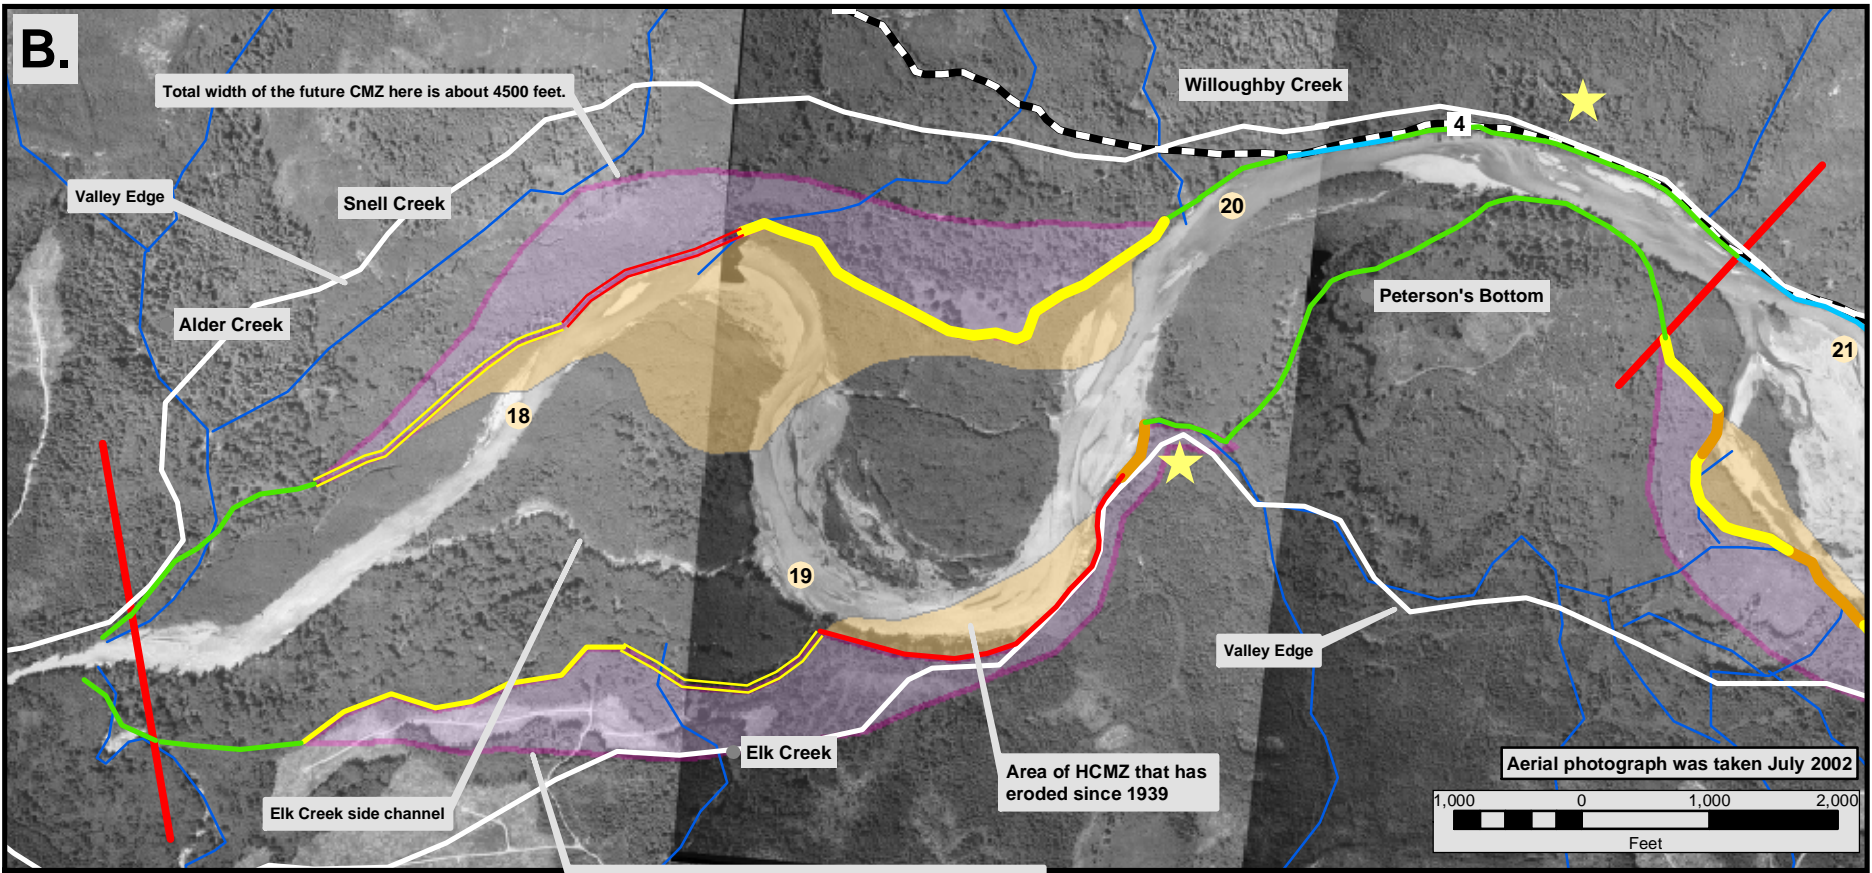
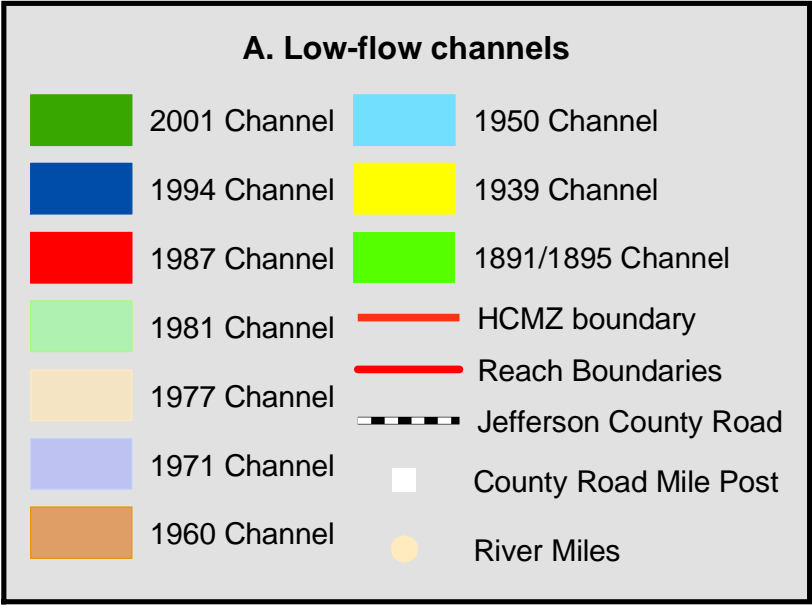
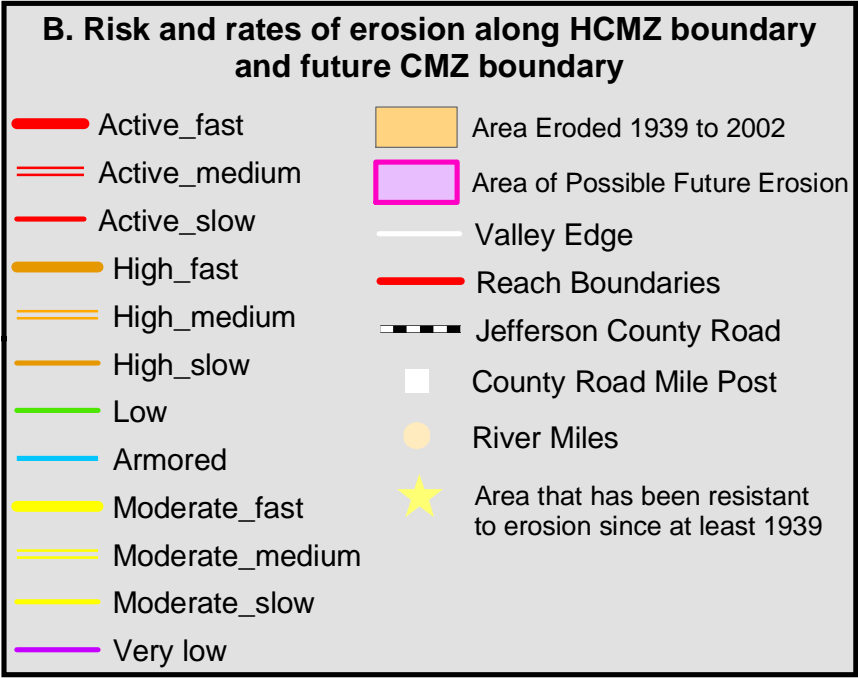
Figure 2.1. Historical channel position, risk assessment, and future channel migration zone boundary for the Willoughby Creek Reach.

- A. Historical channel position between 1891 or 1895 and 2001.
- B. The risk and rates of erosion are shown along the boundary of the historical channel migration zone (HCMZ) by the line segments in varying colors and patterns. Areas of the HCMZ that we speculate could erode in the near future are shown in pink and define the boundary of a future channel migration zone. Sections of the HCMZ boundary that lack pink shading will likely be stable in the near future, and lateral erosion of the boundary is expected to be minimal in these areas. The pink-shaded areas show the maximum extent of expected lateral erosion assuming that no human structures exist. If roads and protected banks are maintained, then they would be the limits of lateral erosion along the HCMZ boundary.

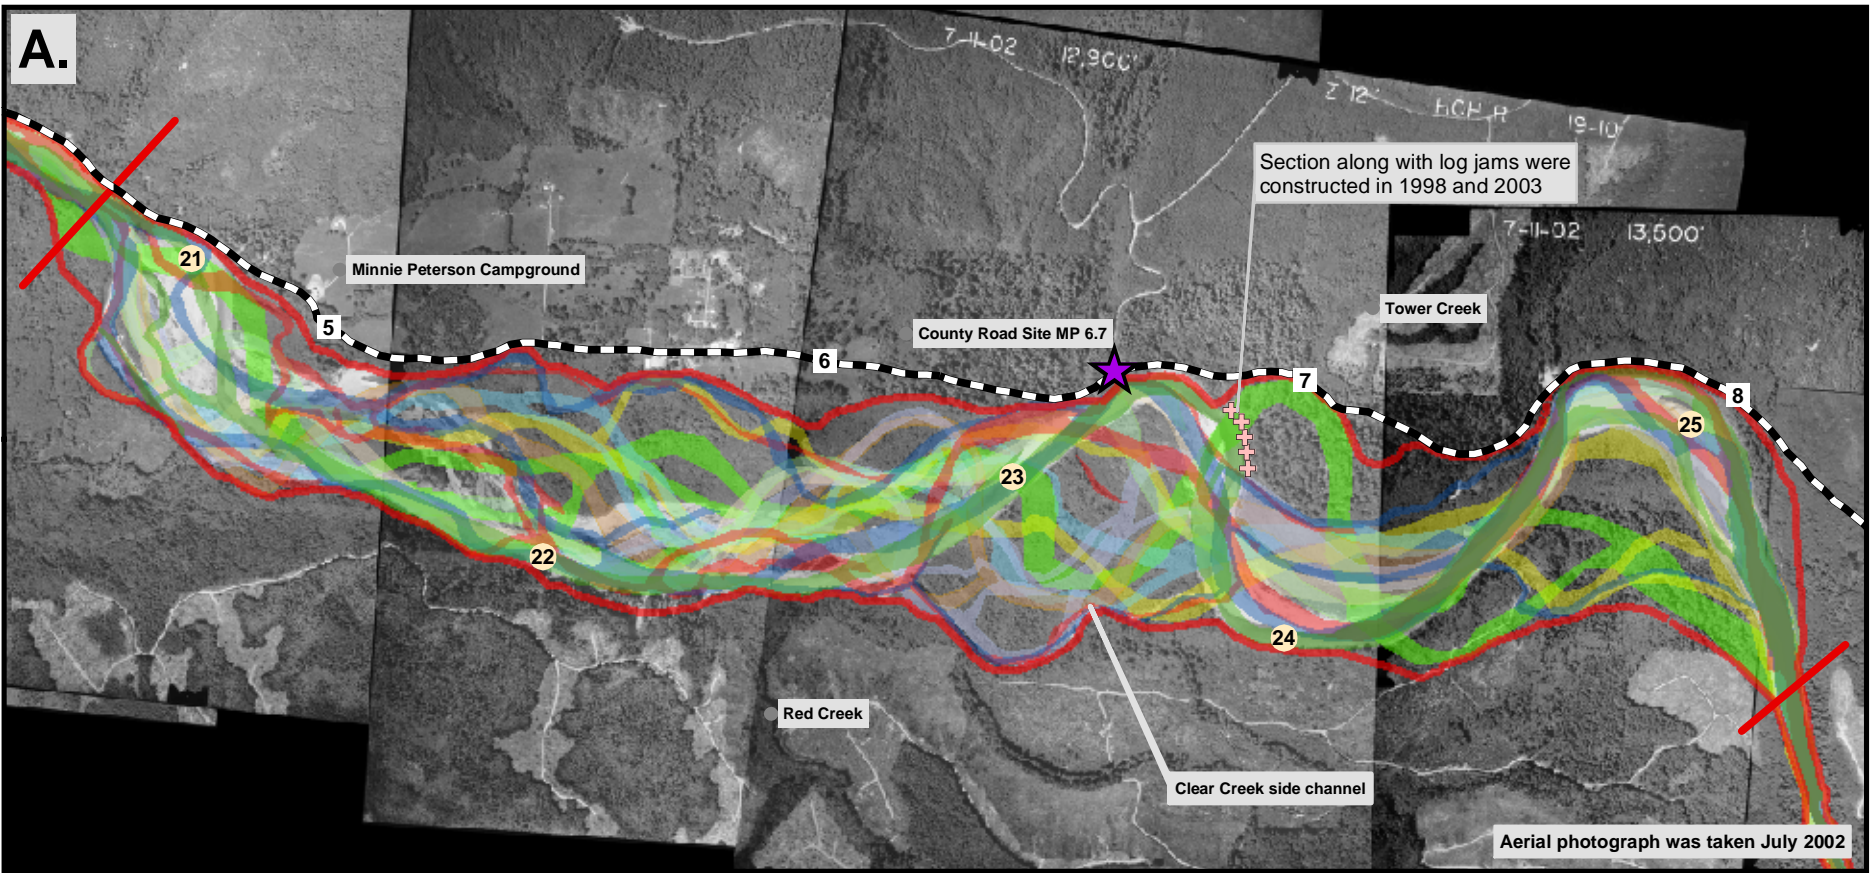
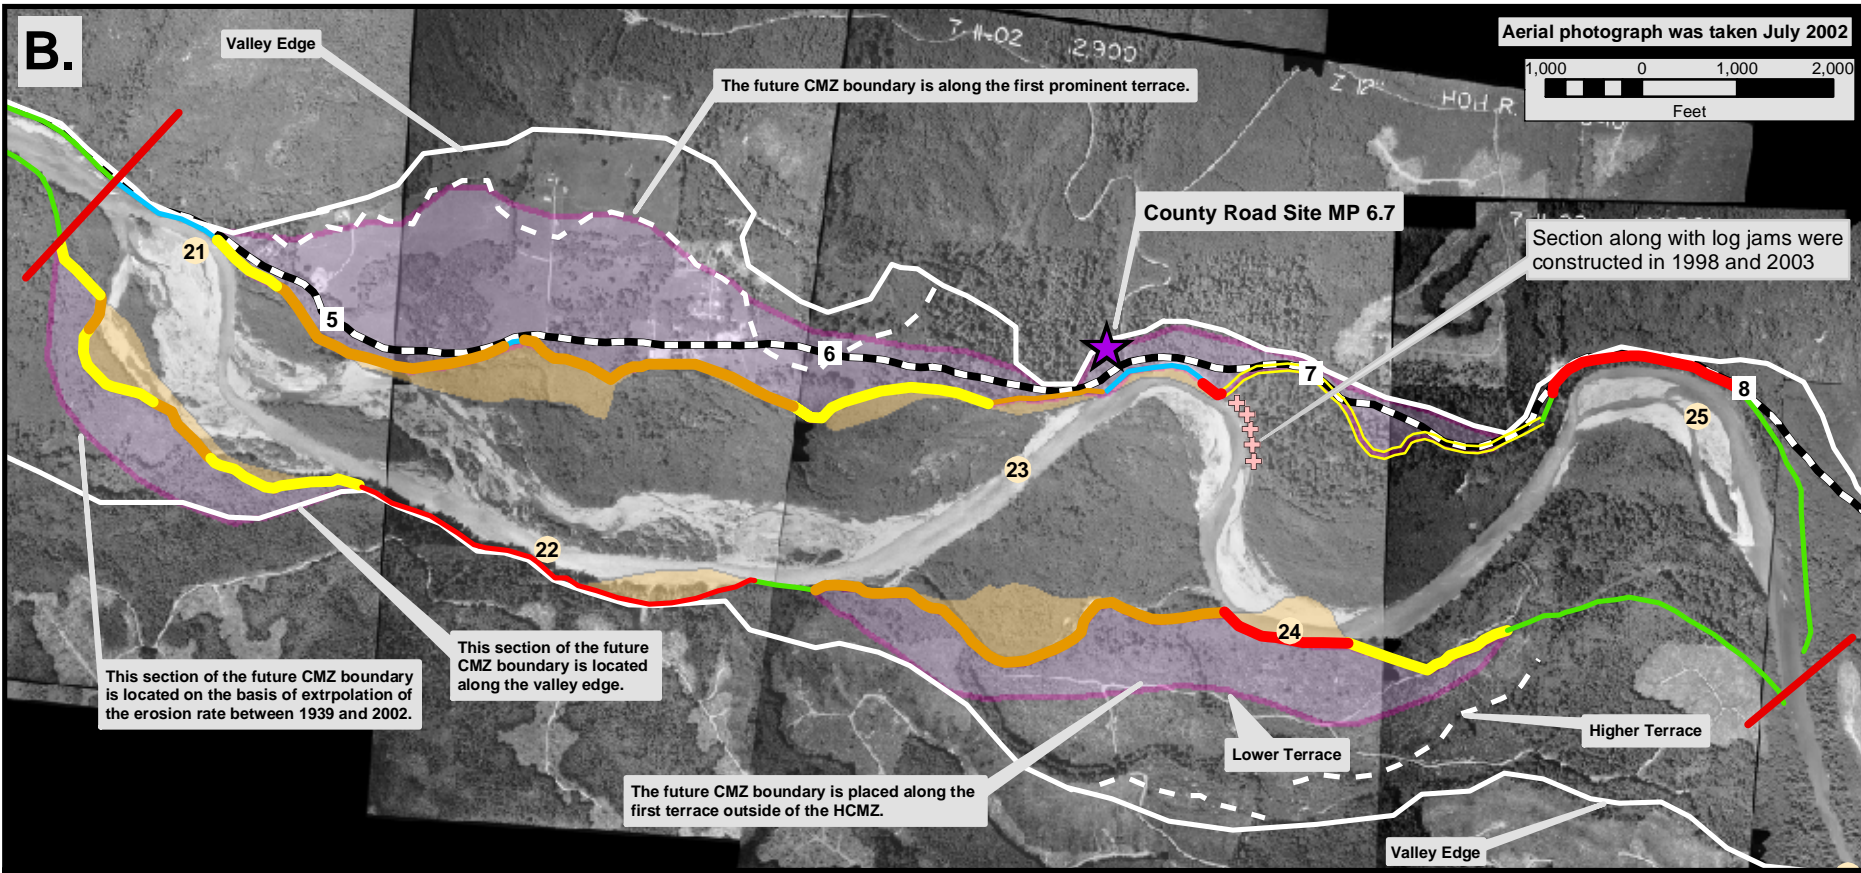
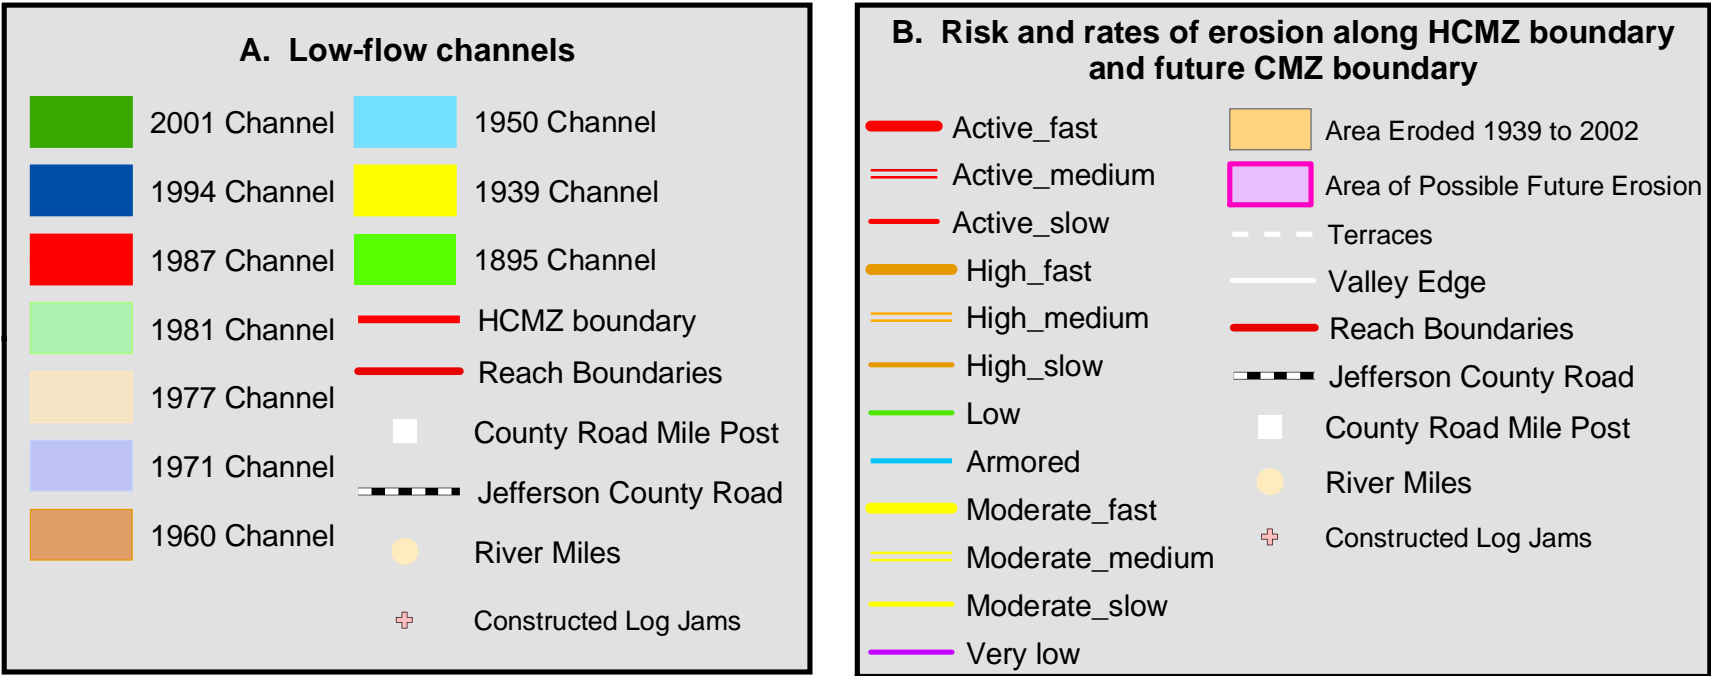
Figure 2.2. Historical channel position, risk assessment, and future channel migration zone boundary for the Morgans Crossing Reach.

B. The risk and rates of erosion are shown along the boundary of the historical channel migration zone (HCMZ) by the line segments in varying colors and patterns. Areas of the HCMZ that we speculate could erode in the near future are shown in pink and define the boundary of a future channel migration zone. Sections of the HCMZ boundary that lack pink shading will likely be stable in the near future, and lateral erosion of the boundary is expected to be minimal in these areas. The pink-shaded areas show the maximum extent of expected lateral erosion assuming that no human structures exist. If roads and protected banks are maintained, then they would be the limits of lateral erosion along the HCMZ boundary.

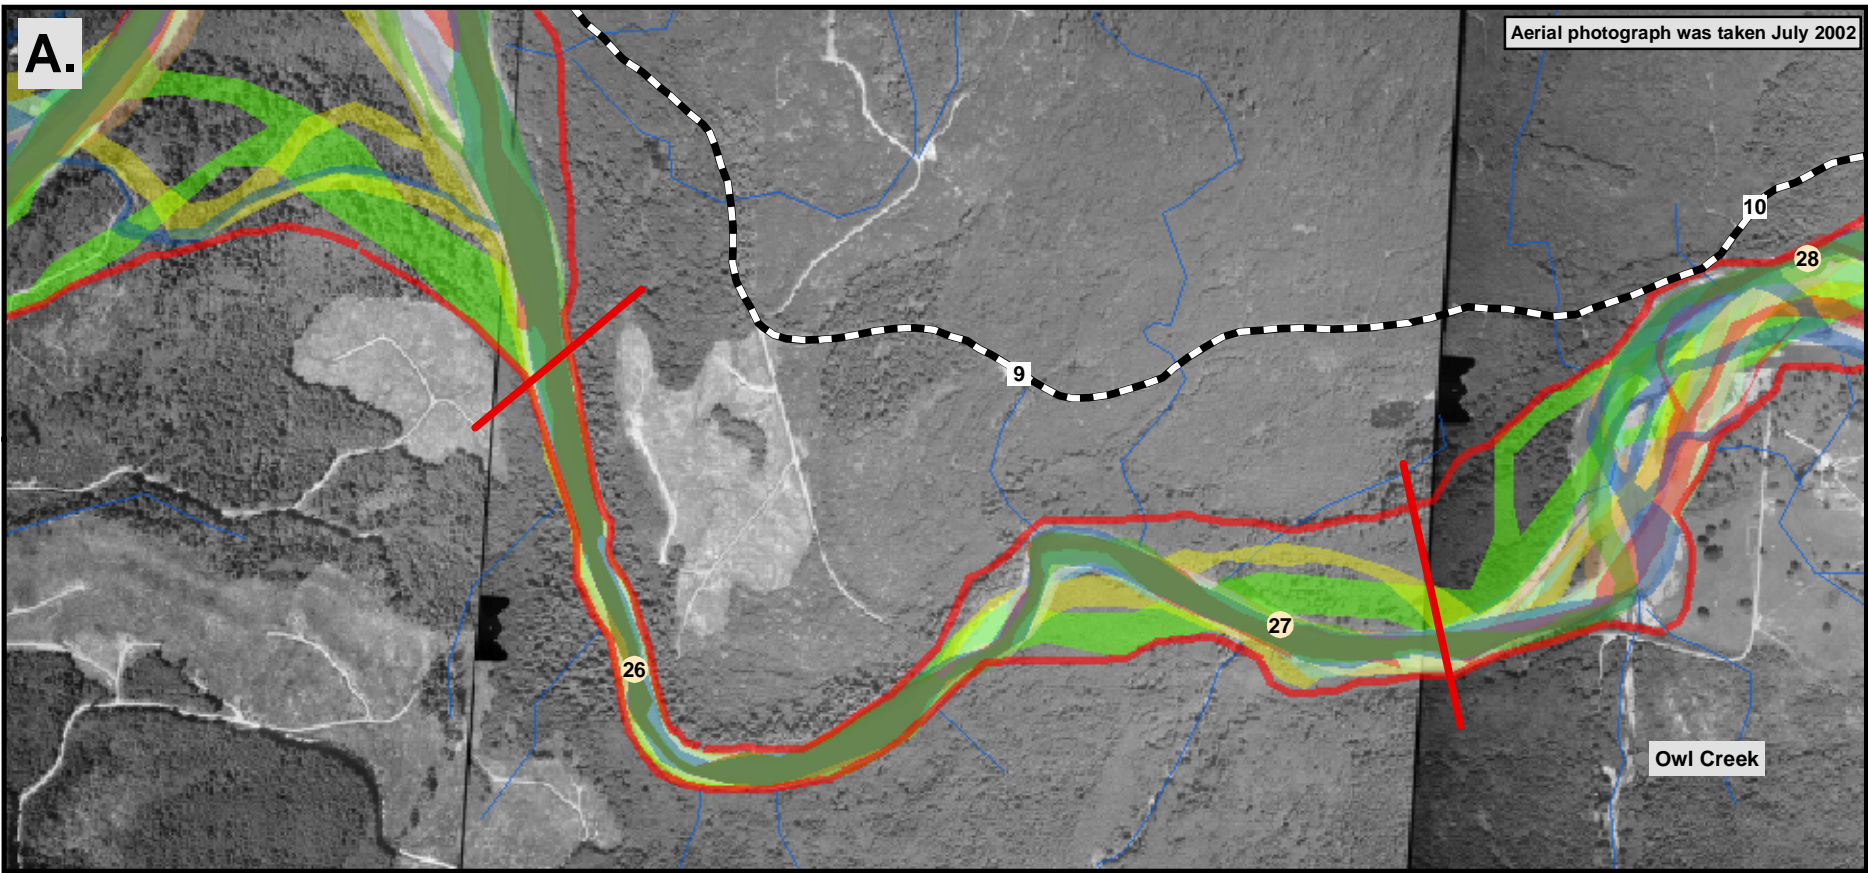
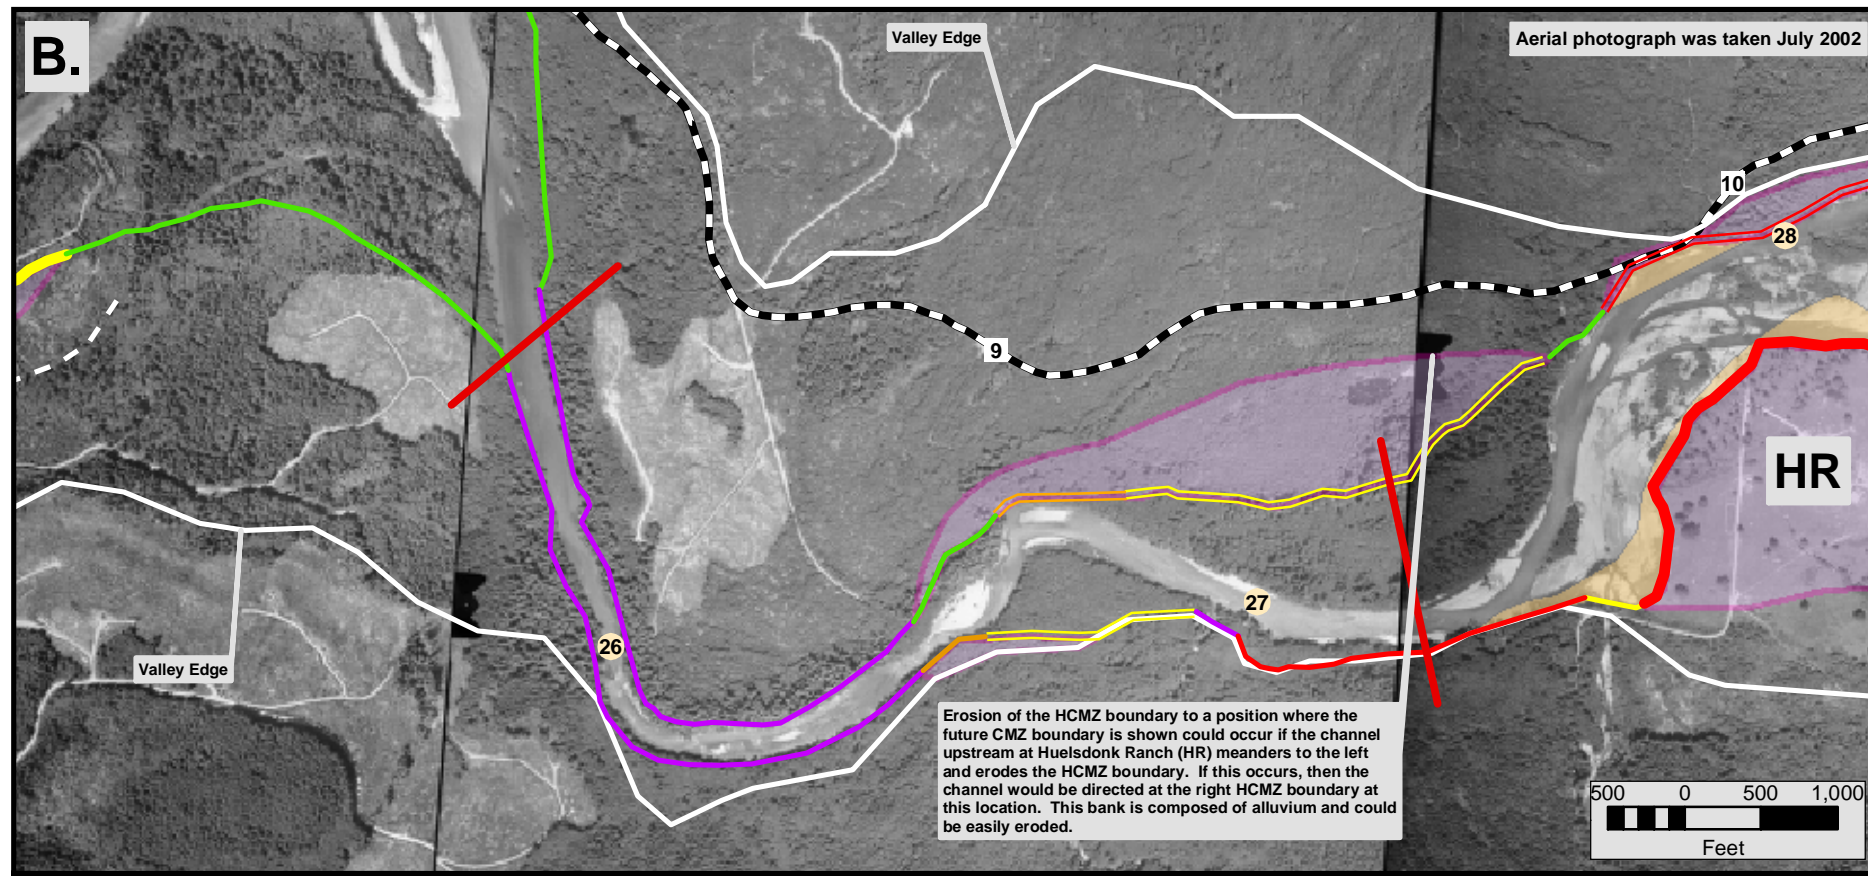
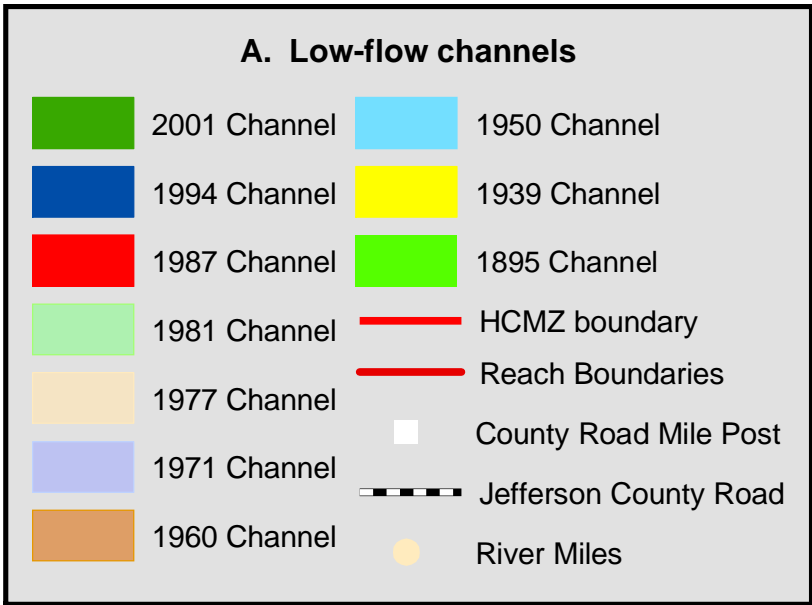
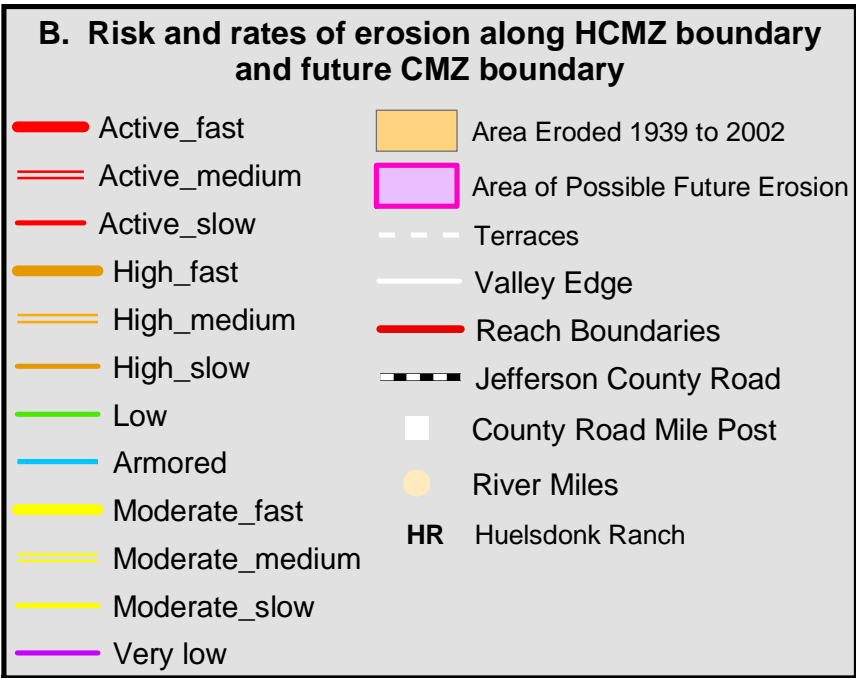
Figure 2.3. Historical channel position, risk assessment, and future channel migration zone boundary for the Spruce Canyon Reach.

B. The risk and rates of erosion are shown along the boundary of the historical channel migration zone (HCMZ) by the line segments in varying colors and patterns. Areas of the HCMZ that we speculate could erode in the near future are shown in pink and define the boundary of a future channel migration zone. Sections of the HCMZ boundary that lack pink shading will likely be stable in the near future, and lateral erosion of the boundary is expected to be minimal in these areas. The pink-shaded areas show the maximum extent of expected lateral erosion assuming that no human structures exist. If roads and protected banks are maintained, then they would be the limits of lateral erosion along the HCMZ boundary.

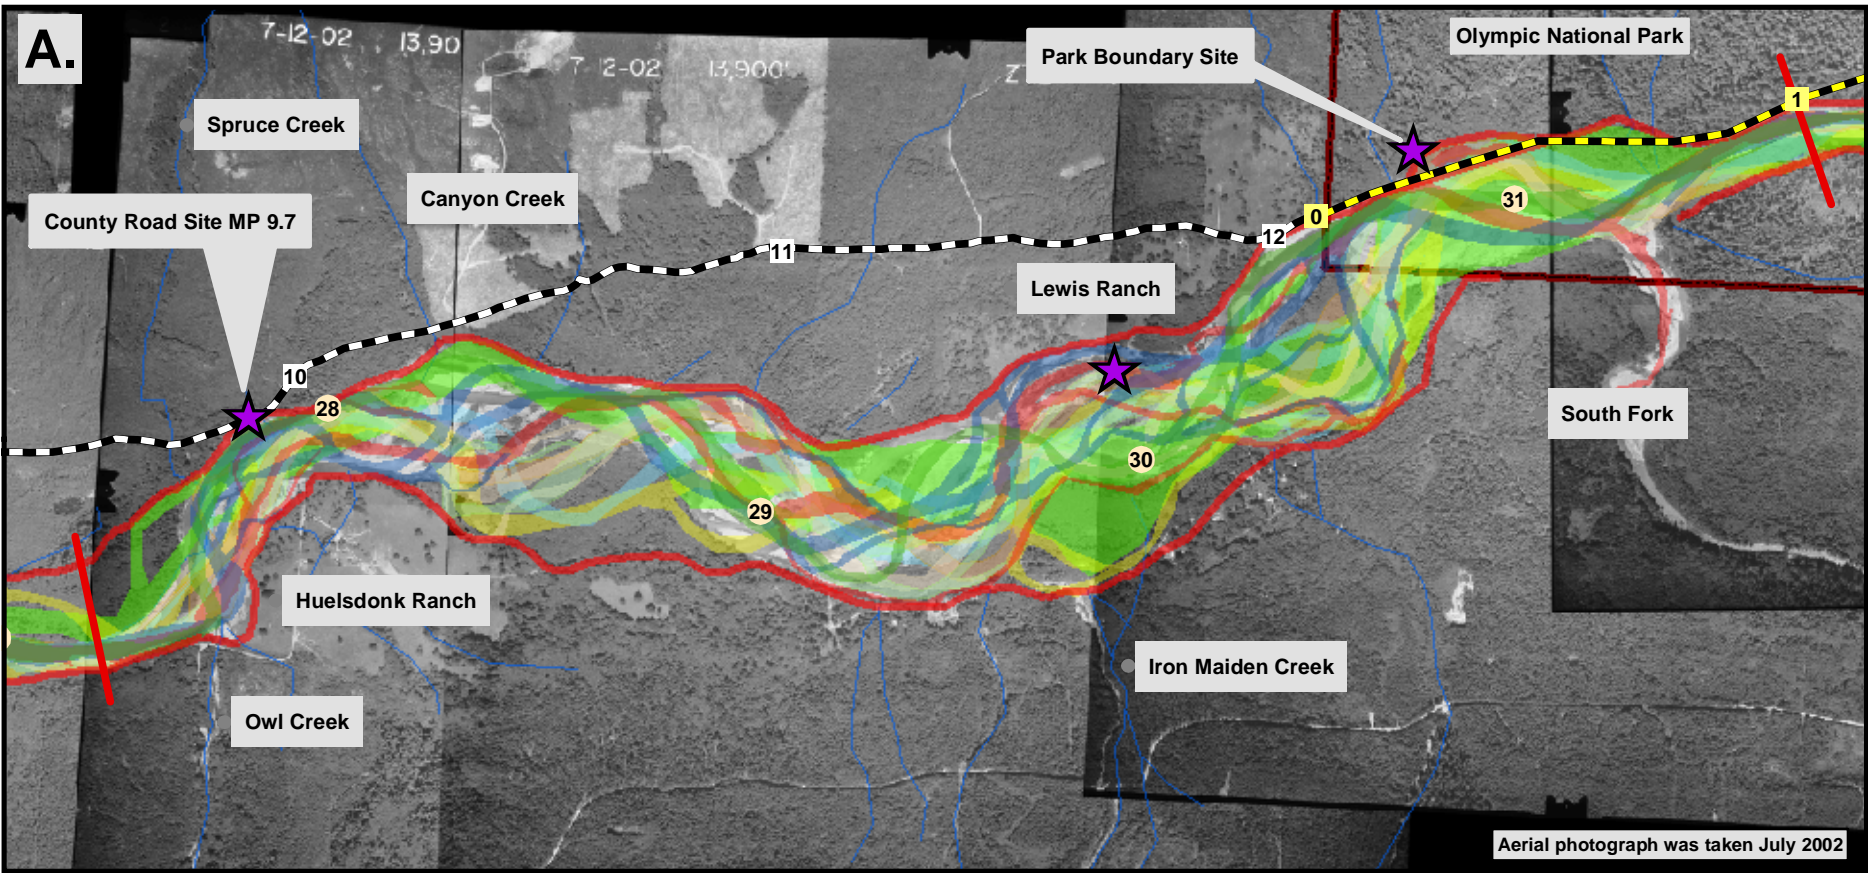
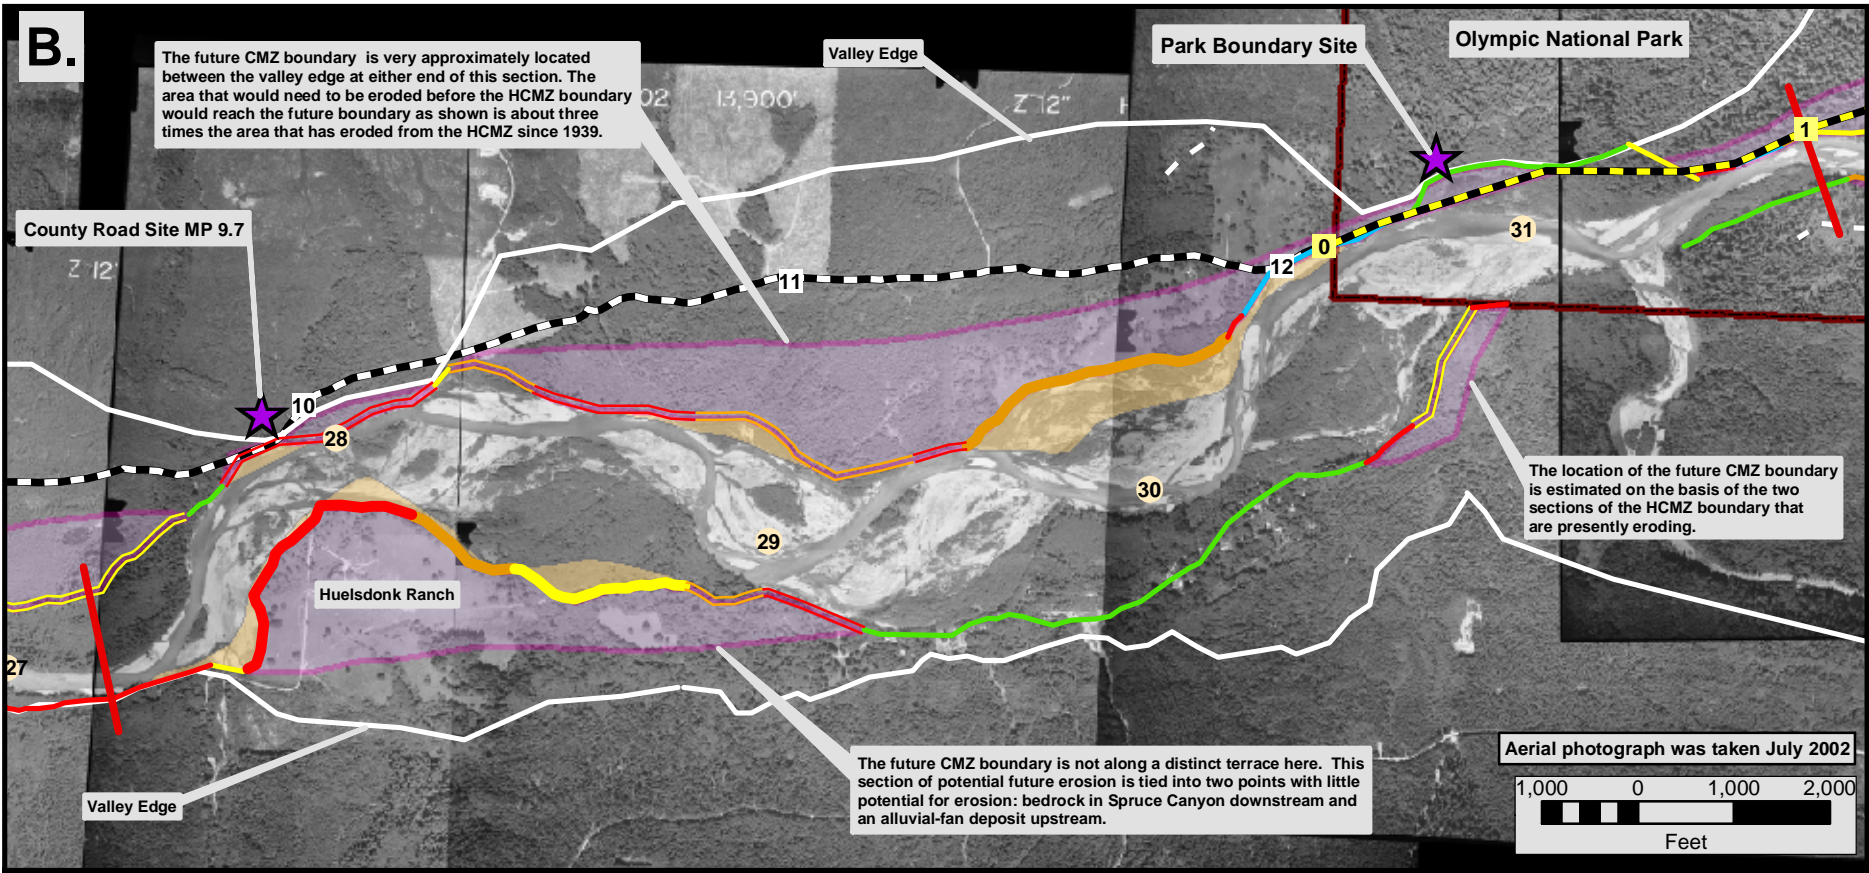
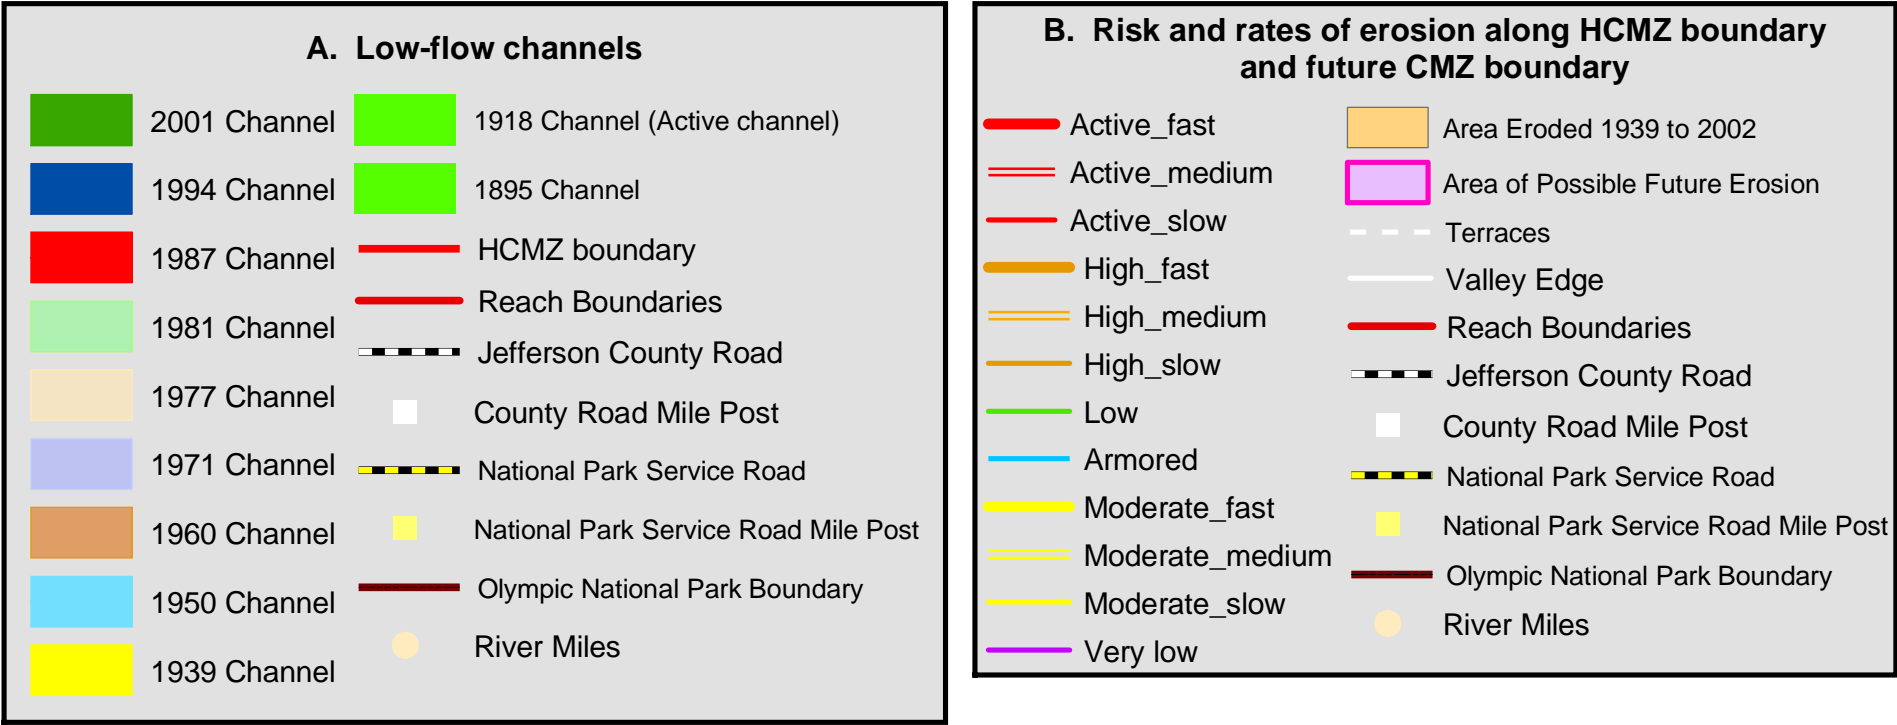
Figure 2.4. Historical channel position, risk assessment, and future channel migration zone boundary for the Huelsdonk-South Fork Reach.

B. The risk and rates of erosion are shown along the boundary of the historical channel migration zone (HCMZ) by the line segments in varying colors and patterns. Areas of the HCMZ that we speculate could erode in the near future are shown in pink and define the boundary of a future channel migration zone. Sections of the HCMZ boundary that lack pink shading will likely be stable in the near future, and lateral erosion of the boundary is expected to be minimal in these areas. The pink-shaded areas show the maximum extent of expected lateral erosion assuming that no human structures exist. If road and protected banks are maintained, then they would be the limits of lateral erosion along the HCMZ boundary.
